Environmental Assessment
Gov. Juan F. Luis North Parking Lot and Ancillary Structures. St. Croix, U.S. Virgin Islands

July 2023

*Environmental Assessment
Governor JFL North Parking Lot and Ancillary Structures*

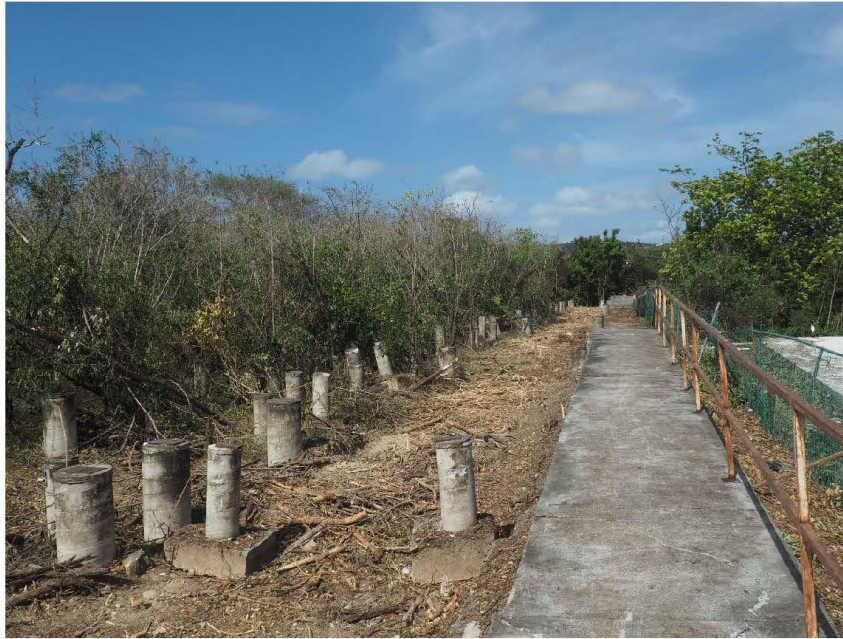
Figure 2. Sidewalk, Pilings, and Secondary Forest.

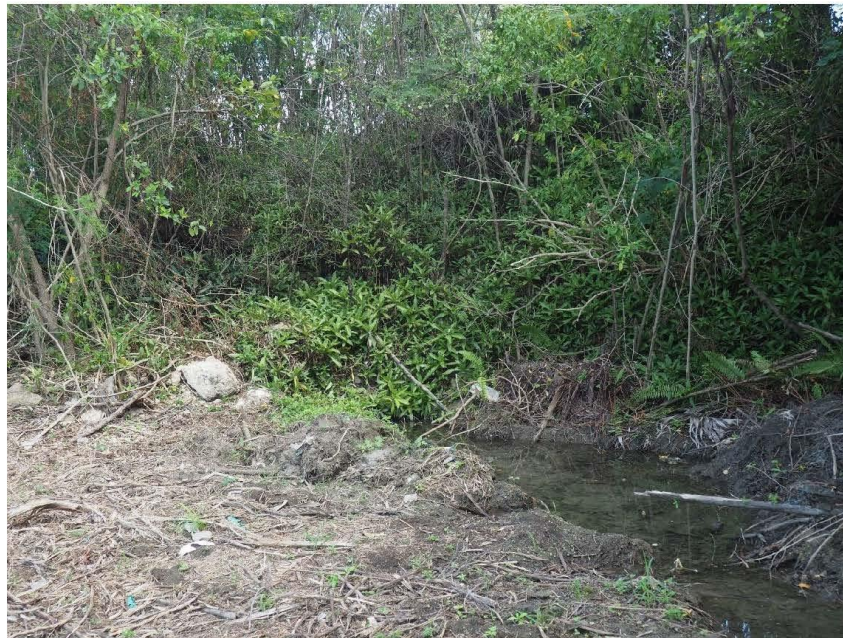
Figure 3. Shaded Drainage Ditch and Steep slope on north edge of property.

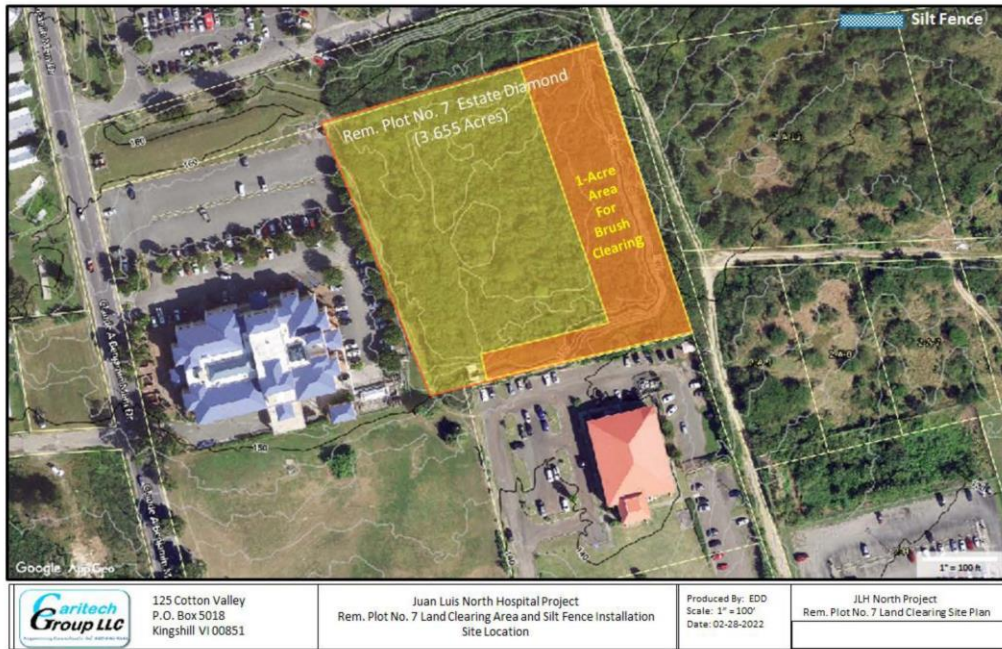
Figure 1. Aerial View of Rem. Plot No. 7, Estate Diamond.
